TECHNICAL REPORT HL-84-3

RIPRAP PROTECTION ON NAVIGABLE WATERWAYS

Stephen T. Maynord

Hydraulics Laboratory
U. S. Army Engineer Waterways Experiment Station
P. O. Box 631, Vicksburg, Miss. 39180

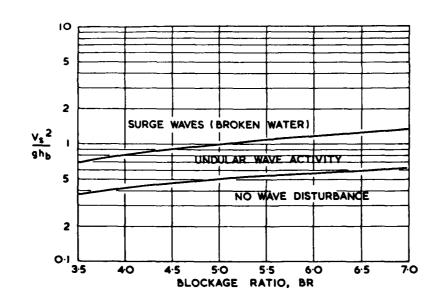
WAVE ACTIVITY ASSOCIATED WITH DRAWDOWN AT THE BERM

DRAWDOWN EFFECTS IN THE SUEZ CANAL (FROM DAND AND WHITE (1977))

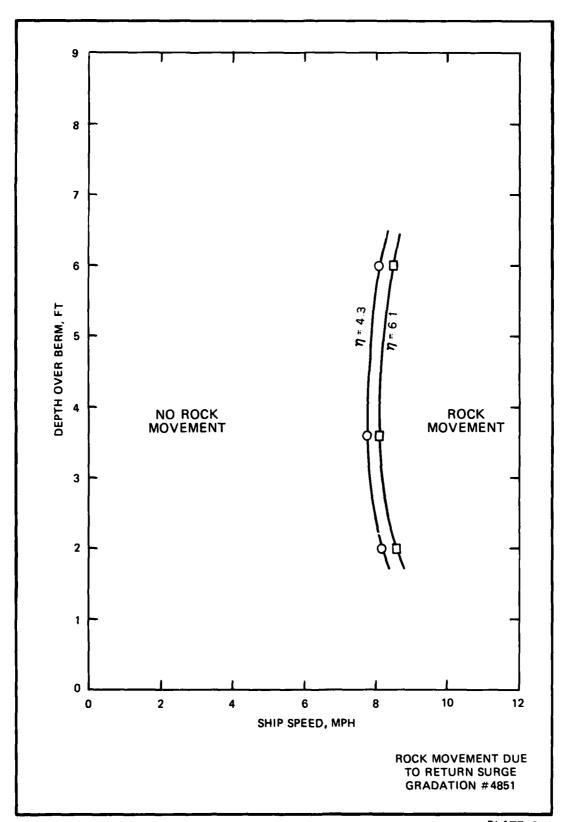
PLATE I-9

- 25. During these tests, the ship speed at which the riprap on the levee began moving was observed for each water depth over the berm and each crosssection ratio for gradation No. 4851. Results of these rock movement

ratio of 4.3 with water depths over the berm of 2, 4, and 6 ft. The replacement rock was moved at ship speeds of \cong 1.0 mph faster than the speeds for the original No. 4851 gradation (Plate I-9) for all depths over the berm.

- 35. Only a small increase (≅ 1.0 mph) in ship speed above the speeds shown in Plate I-9 for gradation No. 4851 can be tolerated without movement of the replacement riprap. This is surprising since the average diameter of the replacement stone is 50 percent greater than the existing riprap. The reason for this small increase is the small cross-section ratio of the SRDWSC to the using vessels. The drawdown curves shown in Plates I-6 and I-7 show a large increase in drawdown (and therefore surge or bore height) for a relatively small increase in ship speed. Only an increase in channel area or a decrease in ship speed can result in favorable conditions within the channel and along the riprapped levees with the using vessels and the proposed replacement riprap.

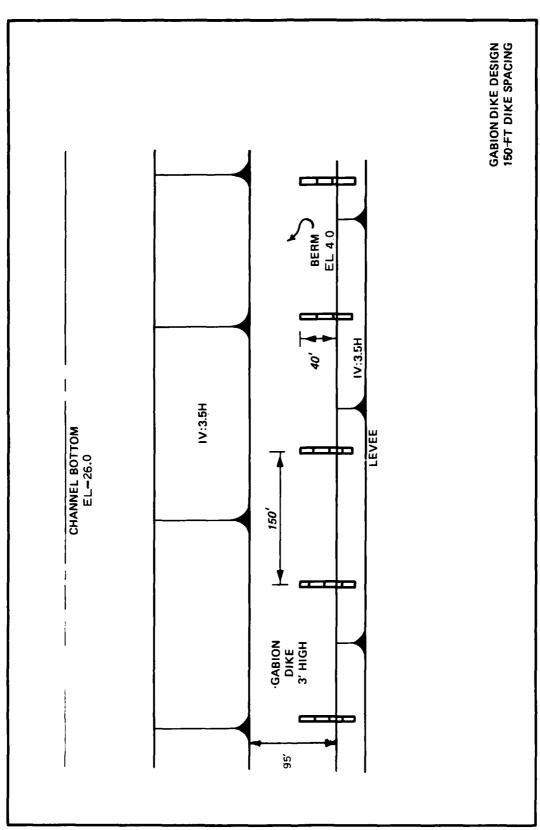
PLATE I-10

- 26. Limited testing was conducted to evaluate the effects of gabion dikes on the levee riprap stability. Gabion dikes were placed along the berm (Plate I-10) at 150-ft intervals. These dikes were 3 ft high and 40 ft in length. Tests were conducted for an η ratio of 4.3 and a 4-ft depth over the berm. Results of the drawdown measurements are shown in Plate I-11. Only a small decrease in drawdown was observed with the gabion dikes. However, the ship speed at which rock movement occurred was increased from approximately 7.8 to 9 mph with the 4-ft depth over the berm and the cross-section ratio of 4.3
